THE TREATMENT OF STEEL SHEET PILES WITH ANTI-CORROSIVE MEANS

W. VRELUST, Ministry of the Flemish Community, Administration of Waterinfrastructure
and Marine Affairs, Service of the Albert Canal
E. VAN DRAEGE, A. VERBEECK, General Coatings nv, B

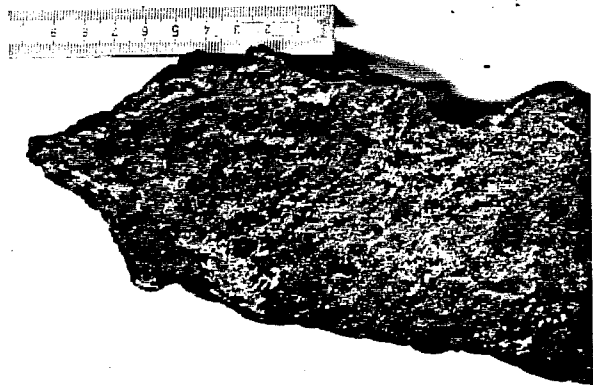
FIG. 6 : Accumulated postules.

Sometimes these postules accumulate to large deposits (see figure 6), which leave after removing them from the sheet pile a deep heavily corroded steel surface.

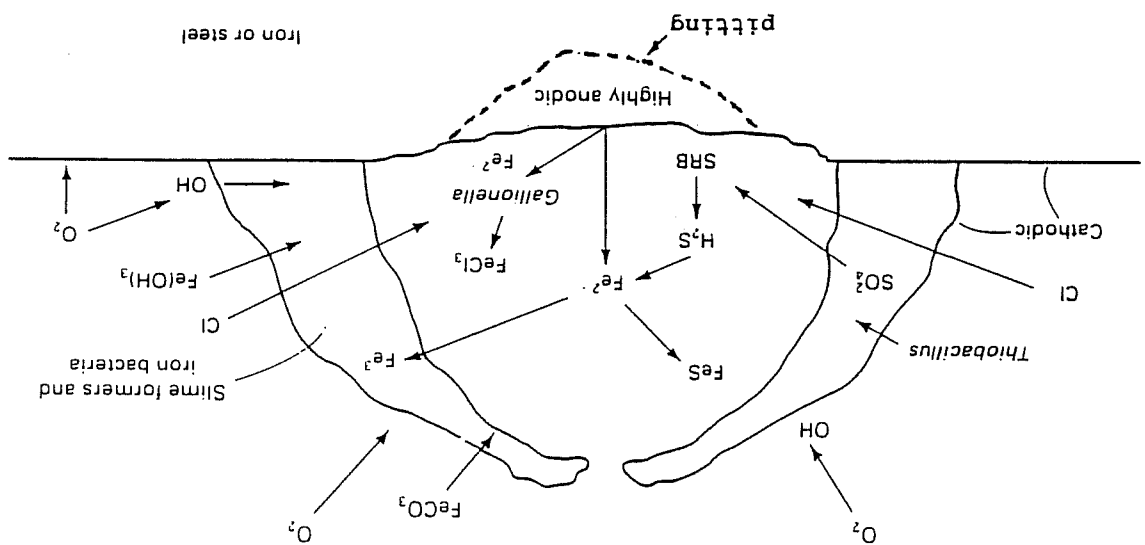
Fig. 11 : Schematic diagram of electrochemical and microbiological processes involved in tuberculation.

A number of reactions that can take place are illustrated in figure 11. The process starts with a deposit of slime-forming and iron-oxidizing bacteria at a point of low flow velocity. Deposition of these microbiological organisms occurs in the form of discrete colonies or at least spotty, rather than continuous films. A schematic representation of such a biofilm is given in figure 12. The slimy biofilm isolates the metal underneath from oxygen creating a so-called oxygen concentration cell. This isolated metal starts to act as an anode promoting the dissolution of iron as Fe^{2+} under the deposit. As the Fe^{2+} ions move outward, they are oxidized to Fe^{3+} , this occurs electrochemically as they encounter

present in the interior anaerobic solution. If present, sulphur oxidizing bacteria may assist in the formation of sulfates as a nutrient for the SRB. The SRB produce the acidic H_2S . This acidic environment promotes corrosion of the metal (production of FeS). If a source of chlorides is present together with the iron-oxidizing bacteria *Gallionella* a highly acidic ferric chloride ($FeCl_3$) solution may form inside the tubercule. Production of FeS and eventually $FeCl_3$ will result in a higher sulphur and chloride concentration in the interior of the tubercule, which was also found in practice (see table 1). As the individual tubercules grow on a surface they may eventually combine to form a mass leaving a severely pitted surface underneath. Although the toxicity of cuprous ions is well known toward biological organisms, this does not mean that copper containing steels are immune to biological effects in corrosion (6). It does mean however, that only those organisms having a high tolerance for copper are likely to have a substantial effect. The sulphur oxidizing bacteria *Thiobacillus thio-oxidans* for example can withstand copper concentrations as high as 2%. This means that corrosive action is possible on copper containing steel sheet pittings.

higher oxygen concentrations and/or by the action of iron bacteria. The resulting corrosion product $Fe(OH)_3$ mingles with the biodeposit to form the wall of the growing tubercule. The outside part of this wall becomes cathodic. As the tubercule matures some of the biomass may start to decompose providing a source of sulfates for the sulfate-reducing bacteria (SRB)
